## YTR260701

**Subject:** Yale Frame Bracket: Load to failure test YFBR75 brackets (without additional bracket on timber) to determine the maximum load capacity.

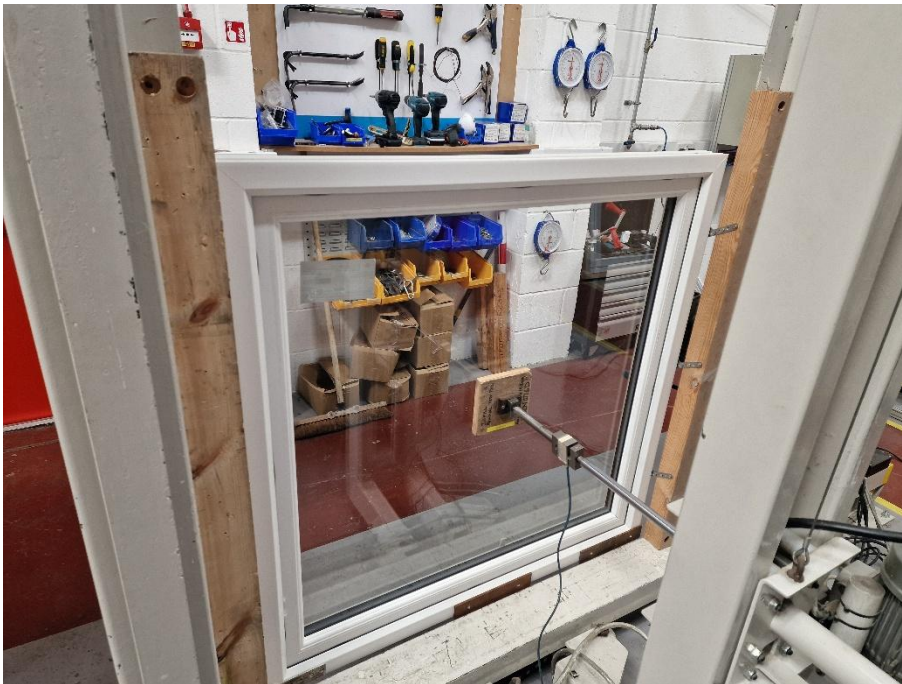
A load was applied to the centre of the toughened glass. The toughened glass exhibited flexing at 2050N, indicating a limitation in further load application for safety reasons. No visible damage to any of the brackets or fixings were observed.

Figure 1: Central load preload being applied.

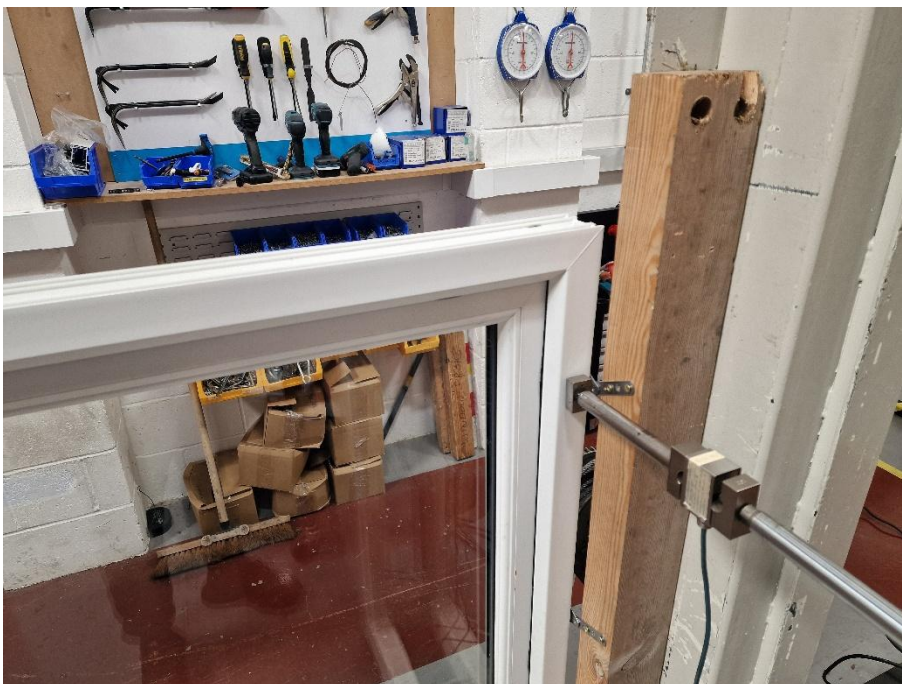
Figure 2: Single bracket load to be taken to failure.

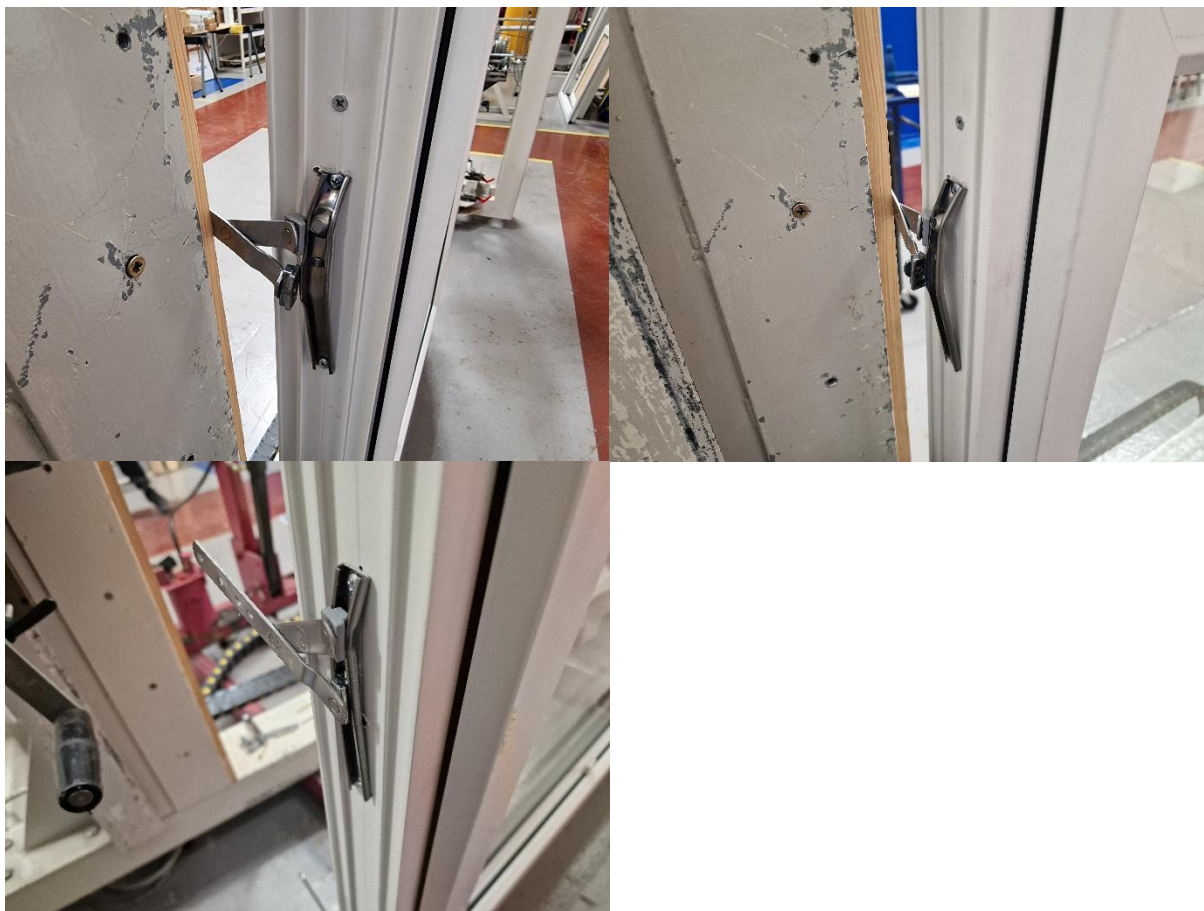
Load applied to a single bracket resulted in failure at 4150N. The failure was attributed to notable deformation observed in the track. This deformation led to the dislodgment of the pivot block, resulting in the complete failure of the bracket assembly.

Figures 3,4 &5: Bracket after single bracket load failure at 4150N
